“17 अक्टूबर, 2003 को मैसर्स सिंगरेनी कोलियरी कम्पनी लिमिटेड की कोयला खानों में हुई बड़ी दुर्घटना, जिसमें 10 लोगों की मृत्यु हुई, के संबंध में जांच अदालत की रिपोर्ट”

मैसर्स सिंगरेनी कोलियरी कम्पनी लिमिटेड के गोदावरीखनी सं. 8ए इन्क्लाइन खान में दिनांक 17 अक्टूबर, 2003 को घटित 10 व्यक्तियों की प्राणघातक दुर्घटना पर

जांच न्यायालय का प्रतिवेदन

NUMERICAL SIMULATION TO ASSESS THE CAUSES OF ACCIDENT DURING DEPIILLARING OPERATION
WITH CAVING IN TOP SEAM NO.1, PANEL NO. 46 BAT GDK-8A INCLINE, RG-2 AREA, SCCL

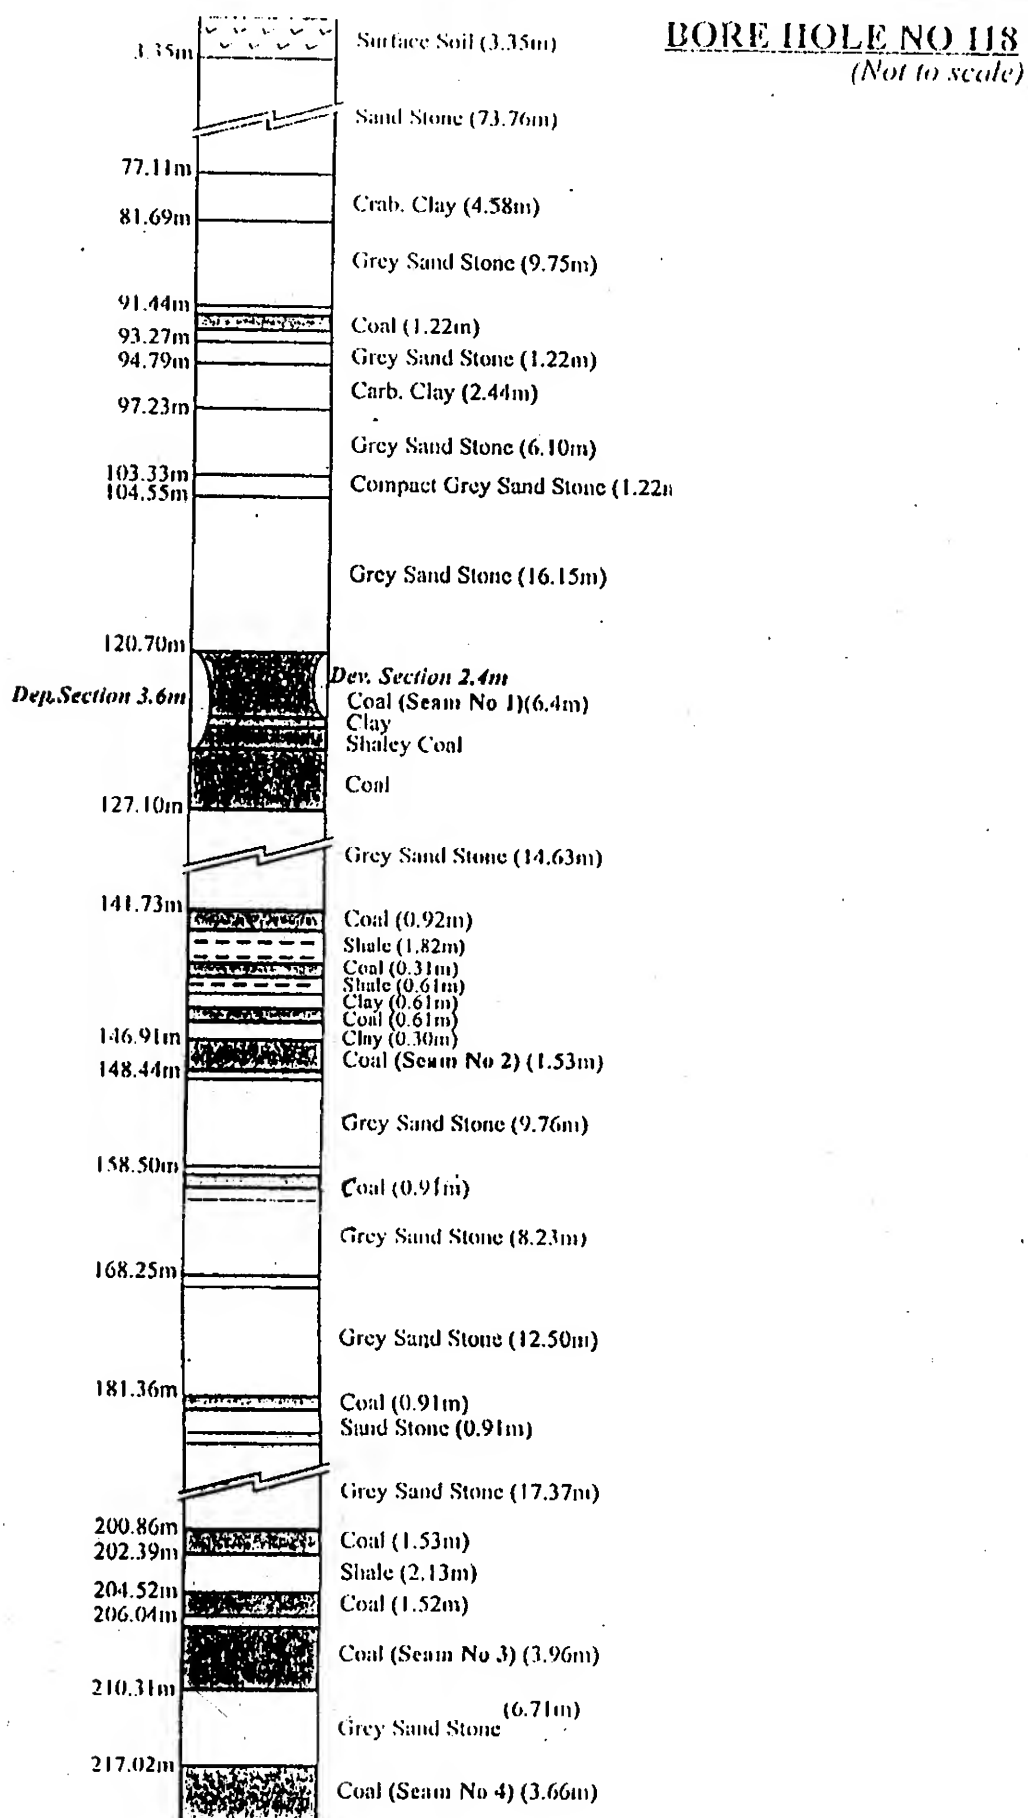
Fig 1: Section along Bore Hole No 118 showing different seams at GDK8A Incline, SCCL.

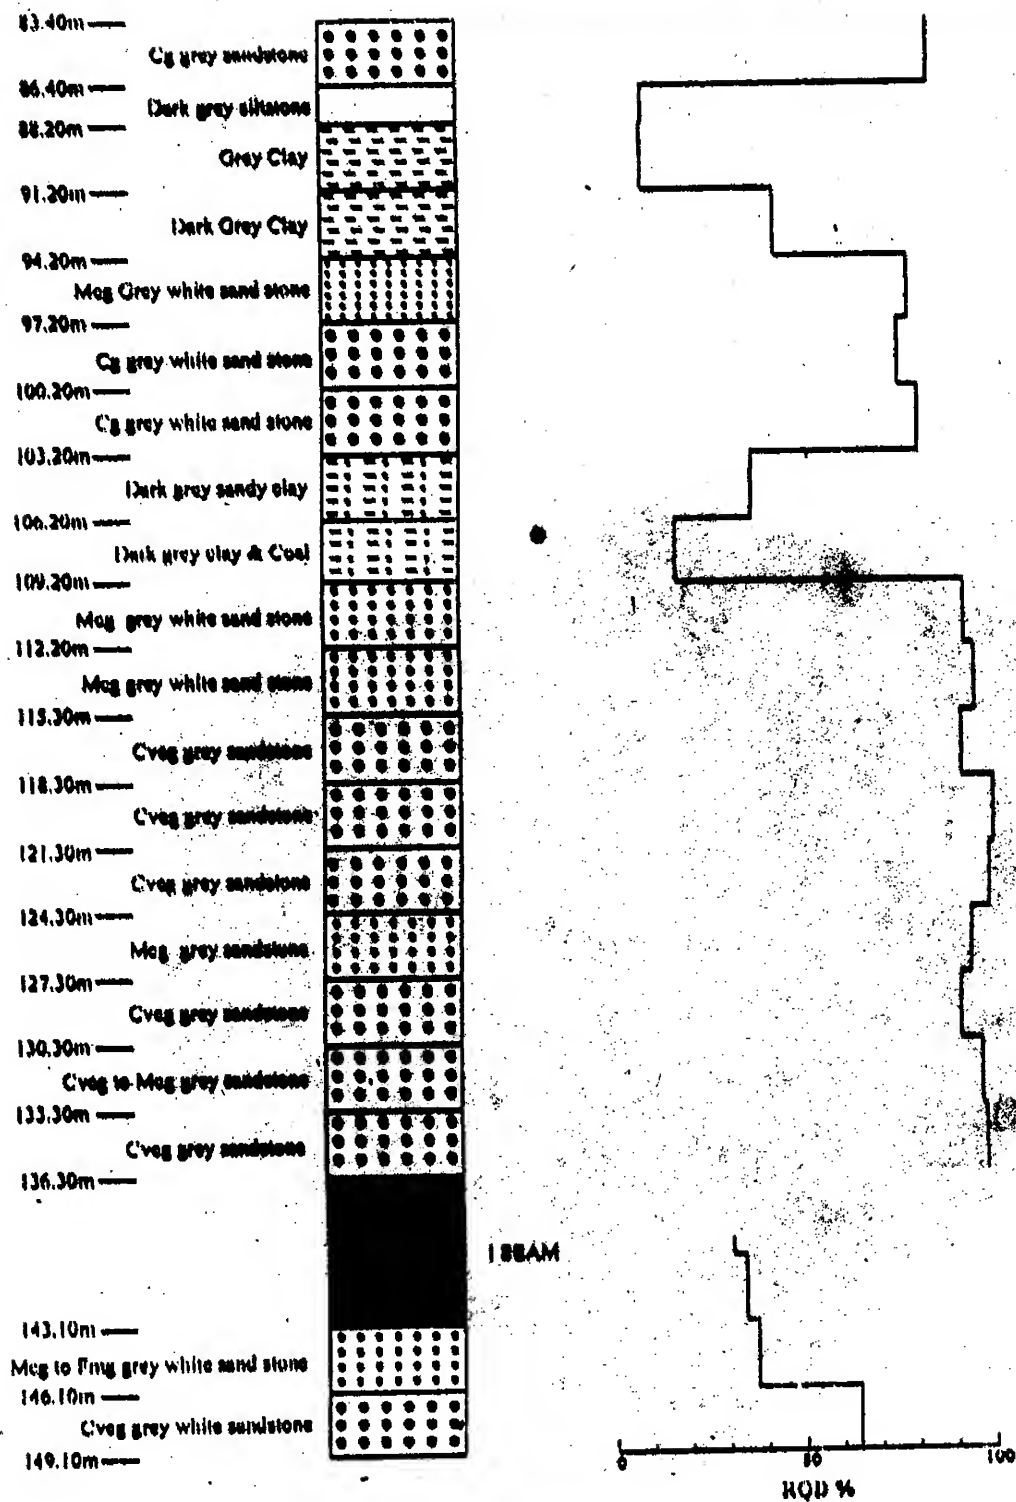
Fig 3: Section along Bore Hole No 1150, located at panel no 46B, where rock samples were tested for modelling purpose.

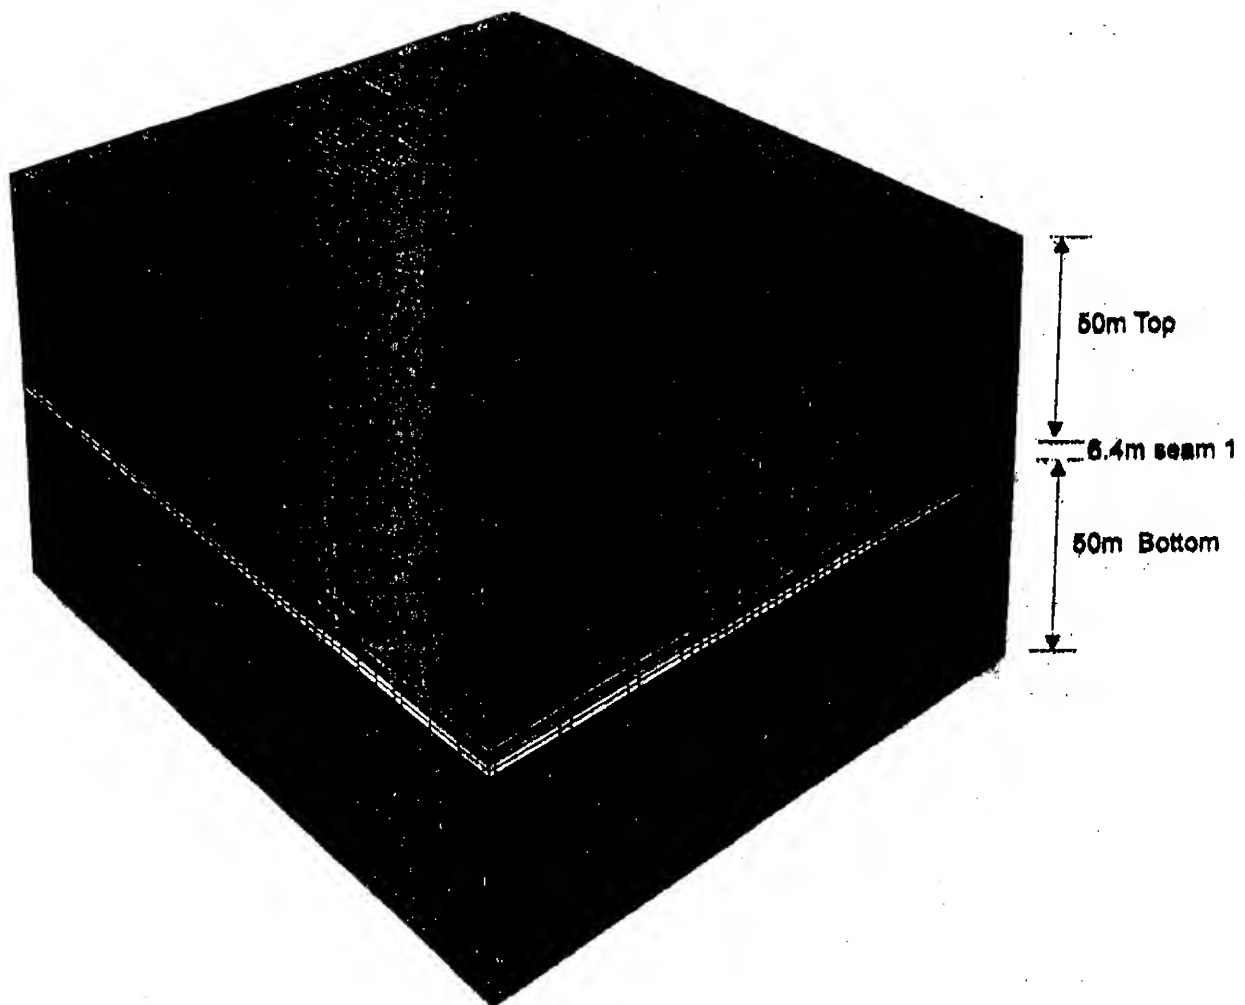
Fig.5: 3-D model showing grid pattern above and below the seam 1 at GDK 8A Incline

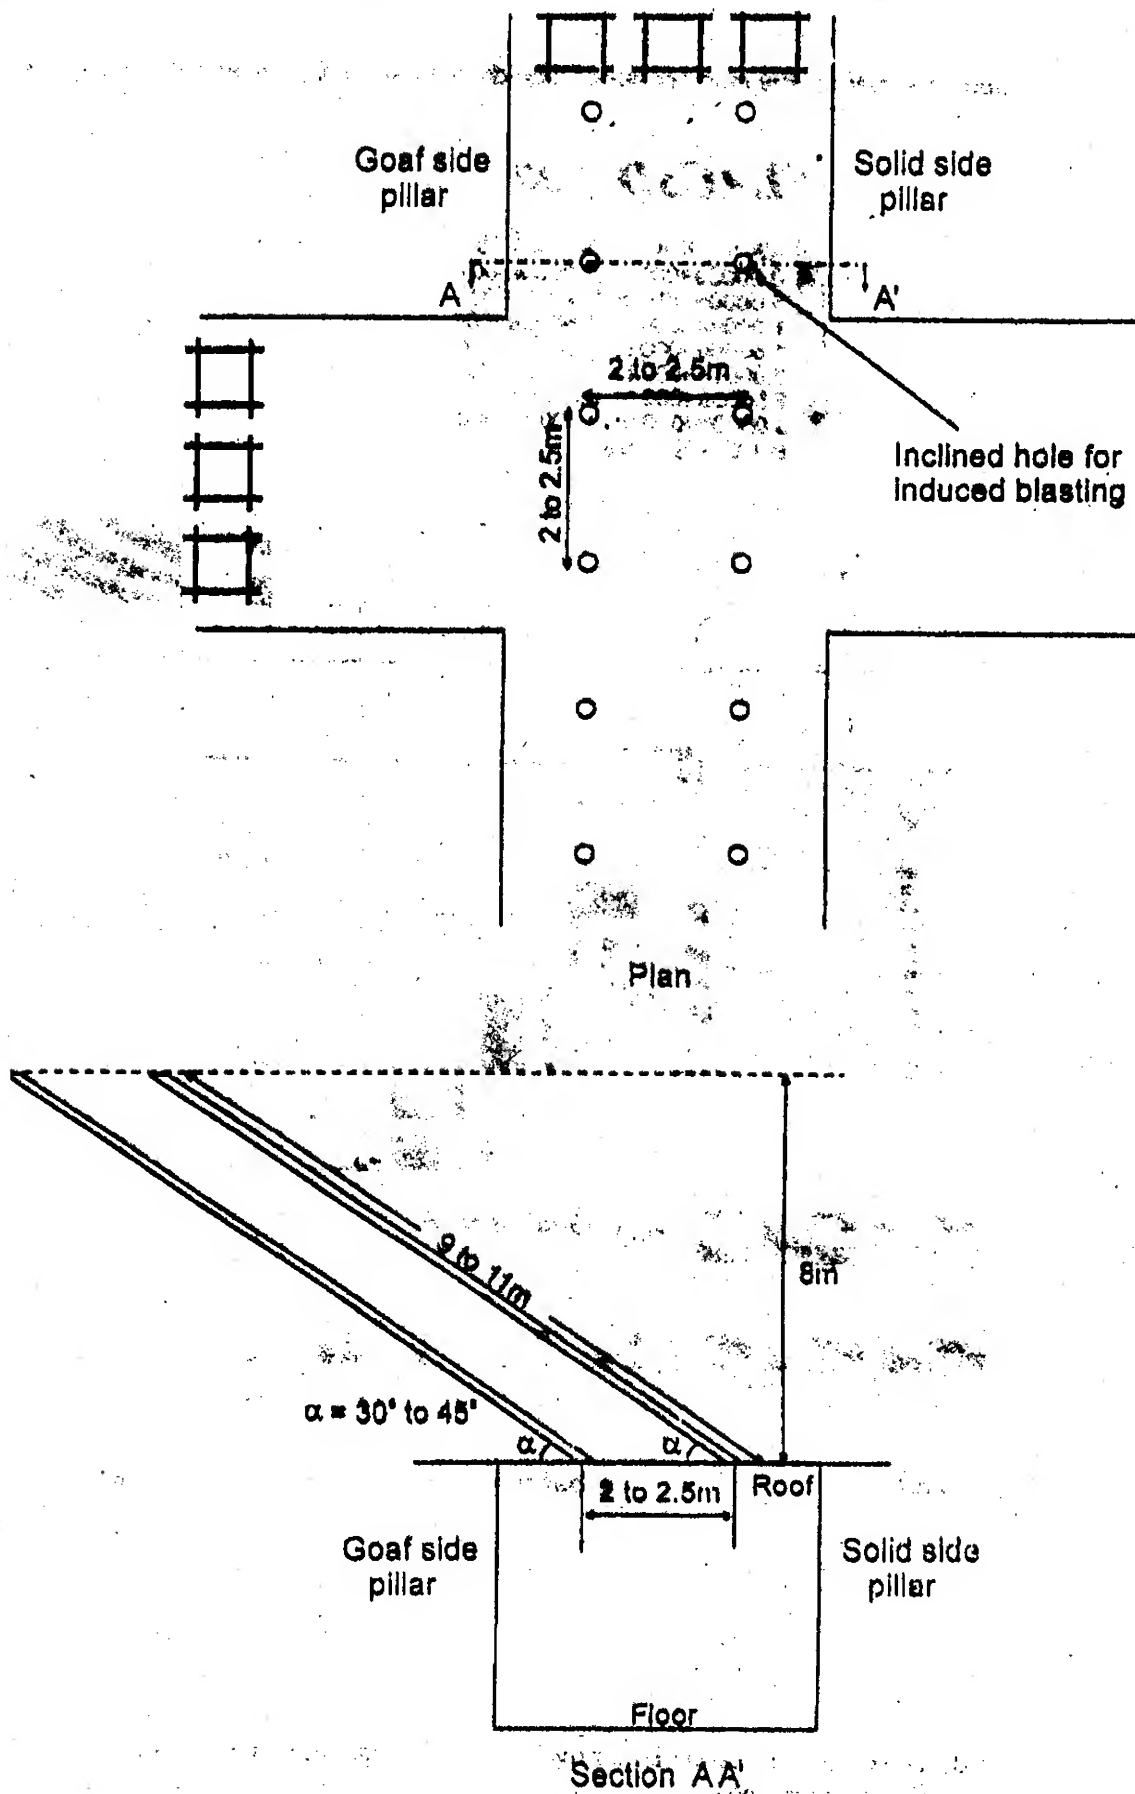
Fig. 9: Goaf edge blasting pattern for induced caving

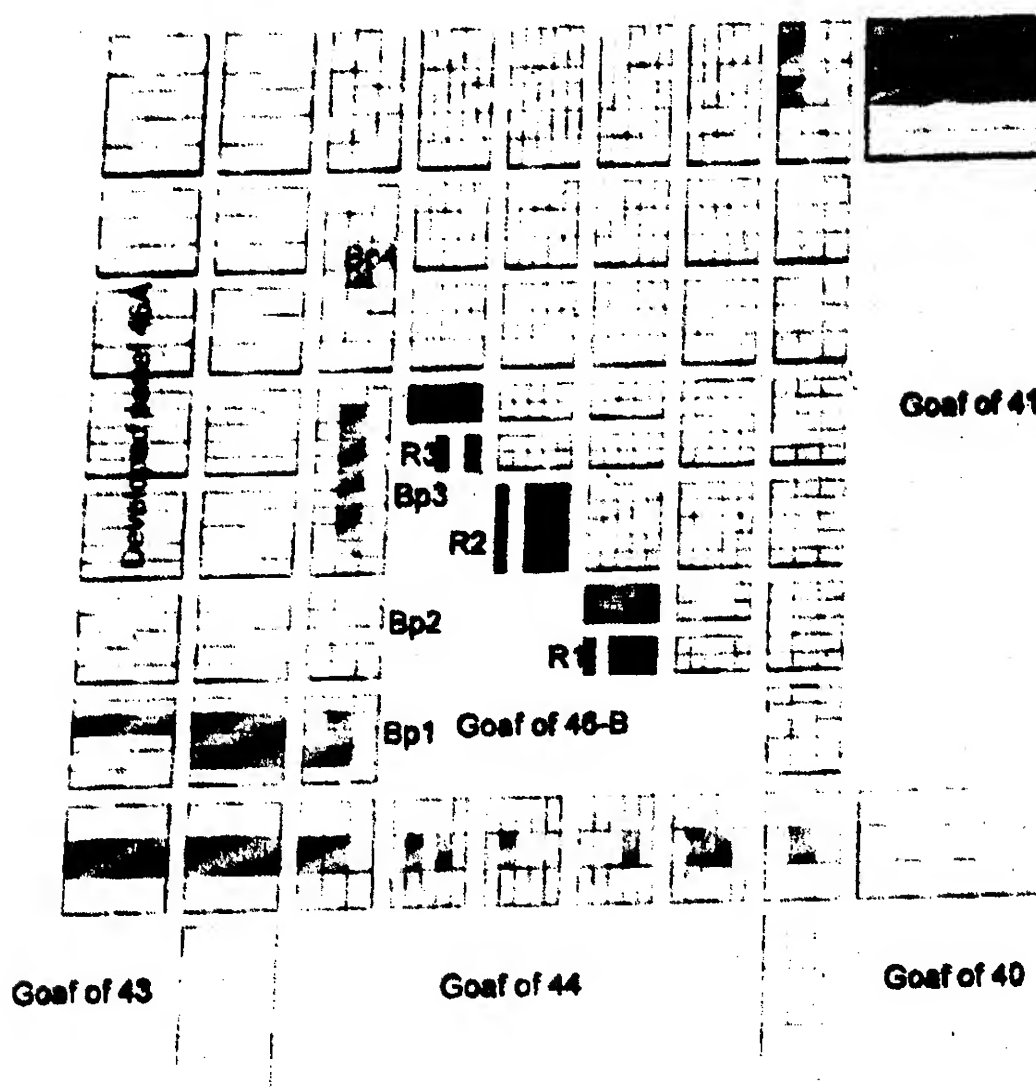
Fig7: Block contours of safety factor over different pillars of panel no 46 B with 46A panel only developed

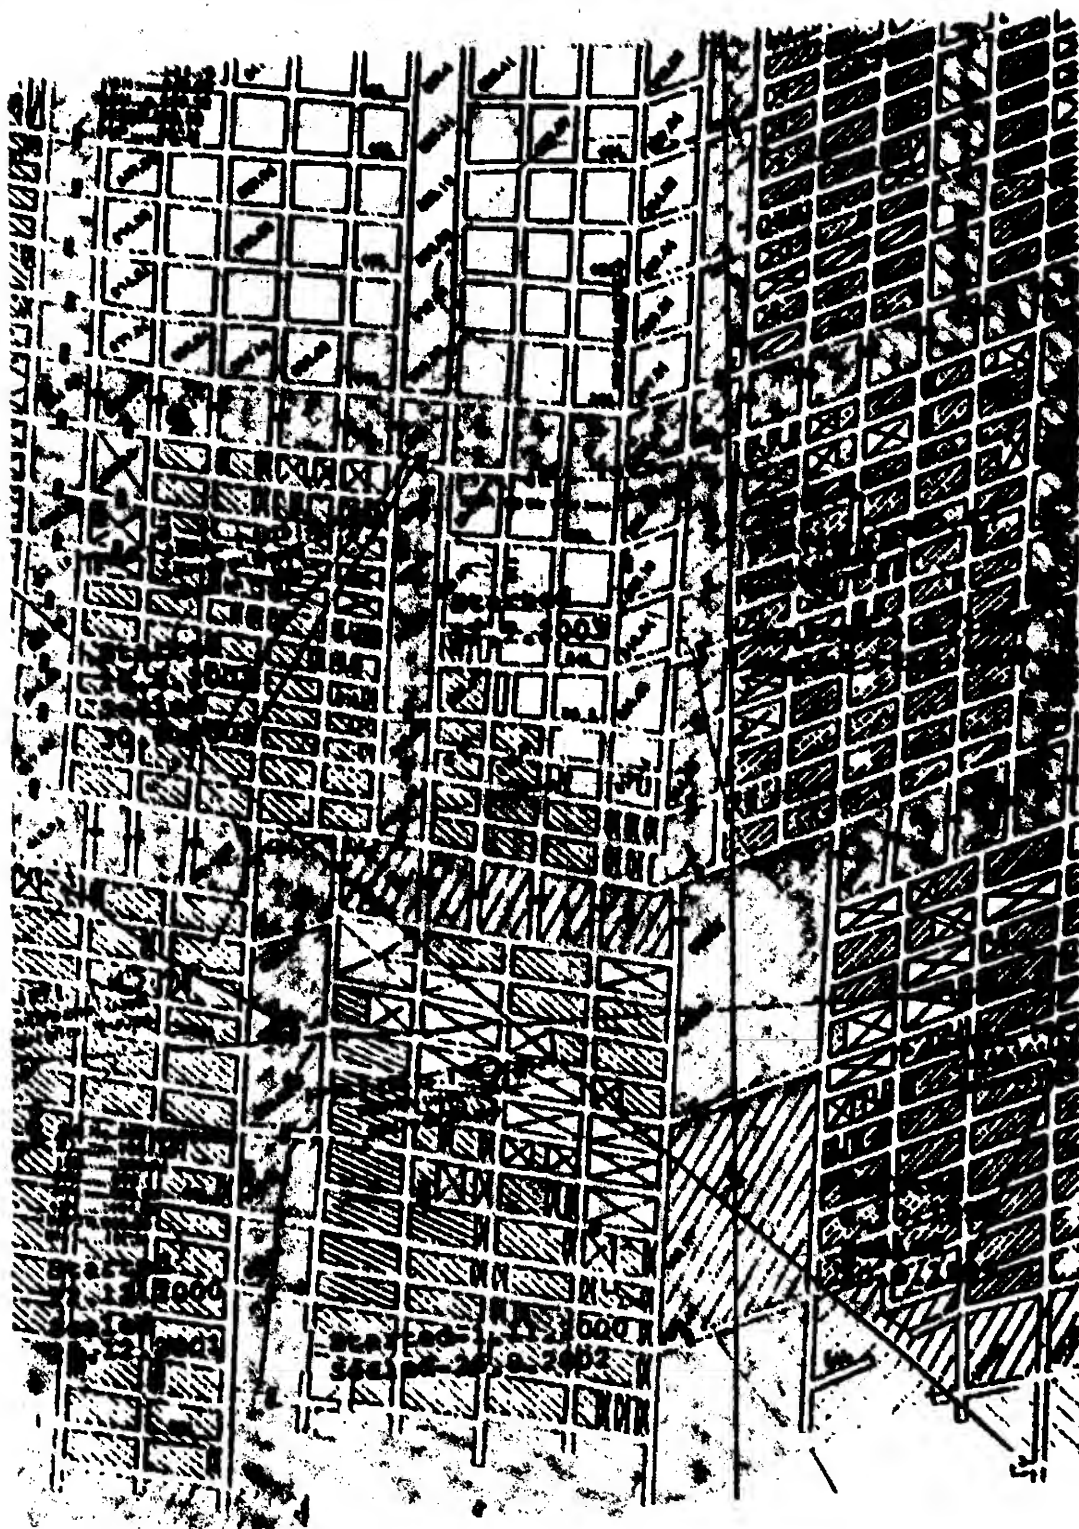
Fig.4 - Working prepositions of different panels
at the time of accident in Panel No.453.

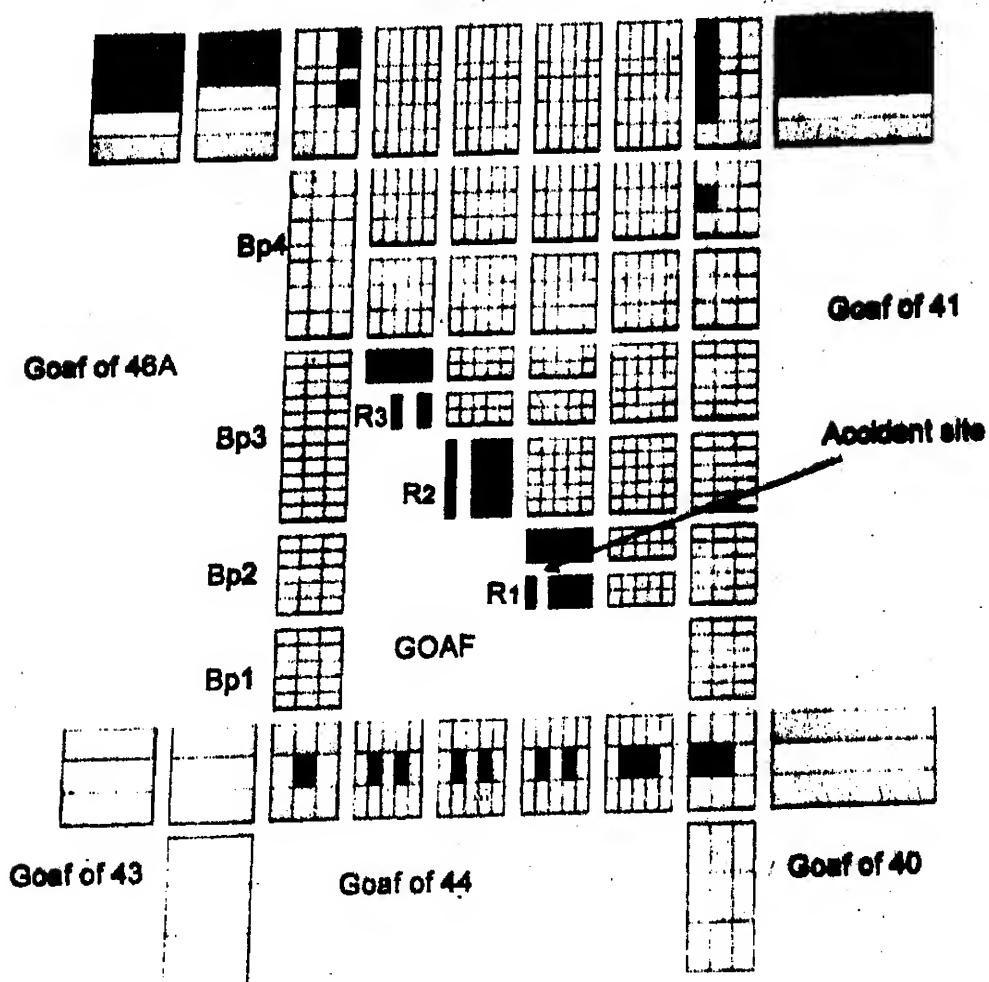
Fig. 6: Block contours of safety factor over the pillars with 3 sides of panel 46-B already extracted

This particular panel No. 46B was also different from others in one particular aspect, and that is that the panel was surrounded on 3 sides by panels already extracted earlier. Management also argued that they had successfully extracted panels No. 11 and 12 with similar conditions of goaves on three sides of the panels under extraction. One major difference between extraction of panel No.46B and those of panels No.11 and 12, is that in case of panels No. 11 and 12, extraction around those panels had been completed long before commencement of extraction in these panels. Whereas, extraction in panel 46B had commenced when extraction in panel 46A was still going on. This means that movement in adjoining panel 46A was continuing while extraction in panel 46B was in progress. Normally, the abutment load generated due to extraction in the adjoining panel would be adequately borne by the intervening panel barrier wherein pillars are generally as per provisions of Reg.99. In this connection, CMRI, in their report had mentioned about the interaction of the stresses generated due to movement in the adjoining goaf which would be discussed later.

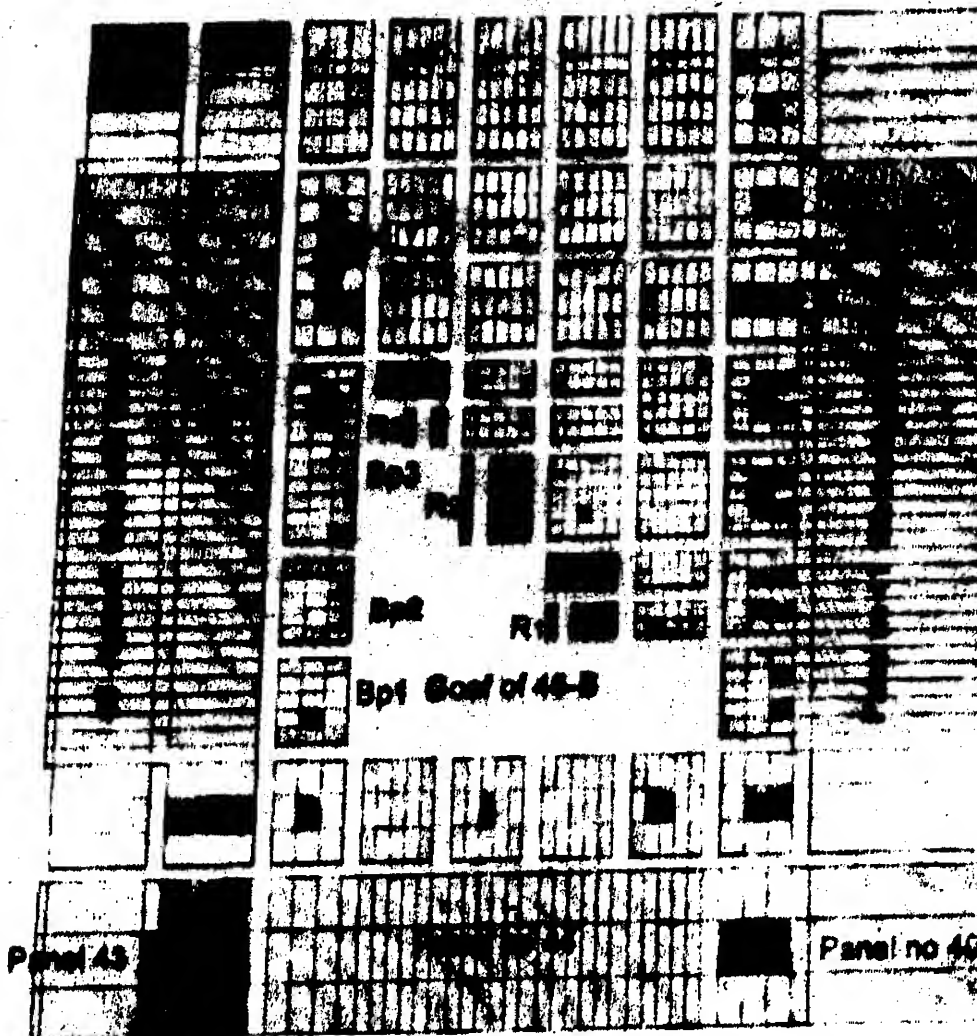
Fig. 8: Block contours of safety factor over pillars with 3 sides of the panel no 46-B was extracted but goaf was completely settled

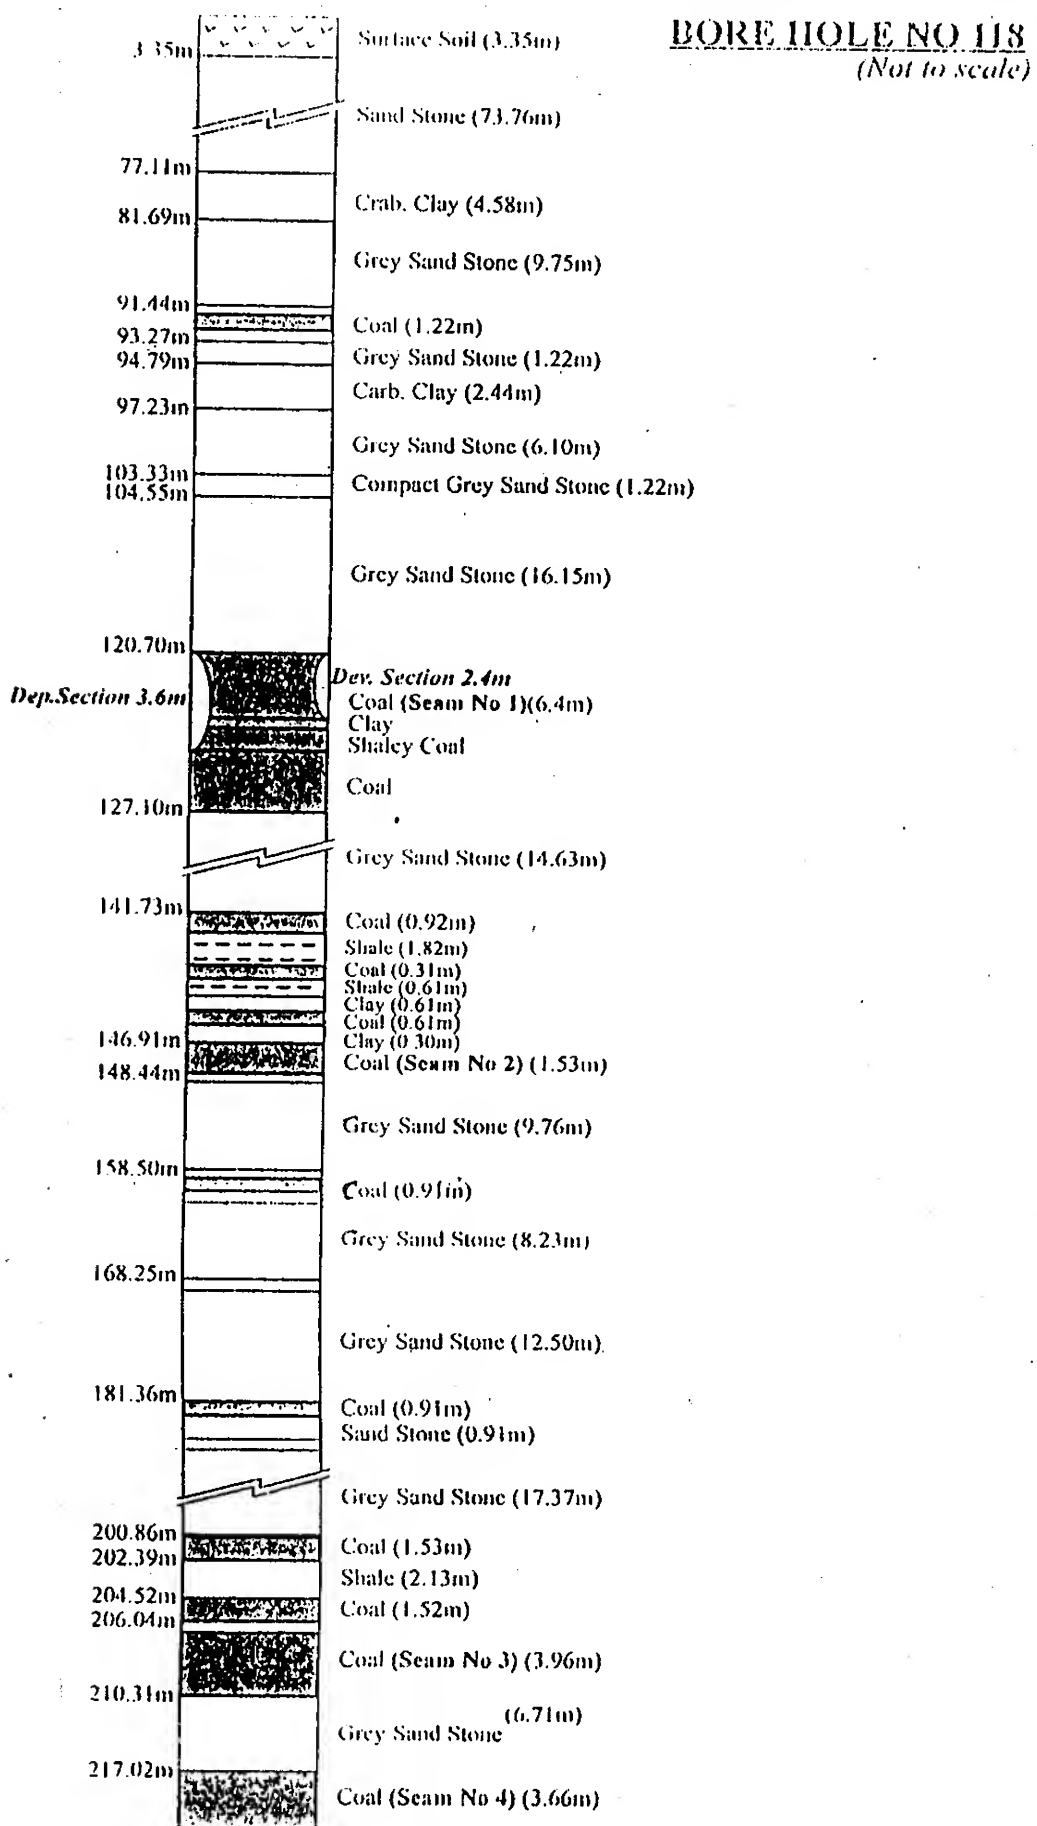
Fig 1: Section along Bore Hole No 118 showing different seams at GDK8A Incline, SCCL.

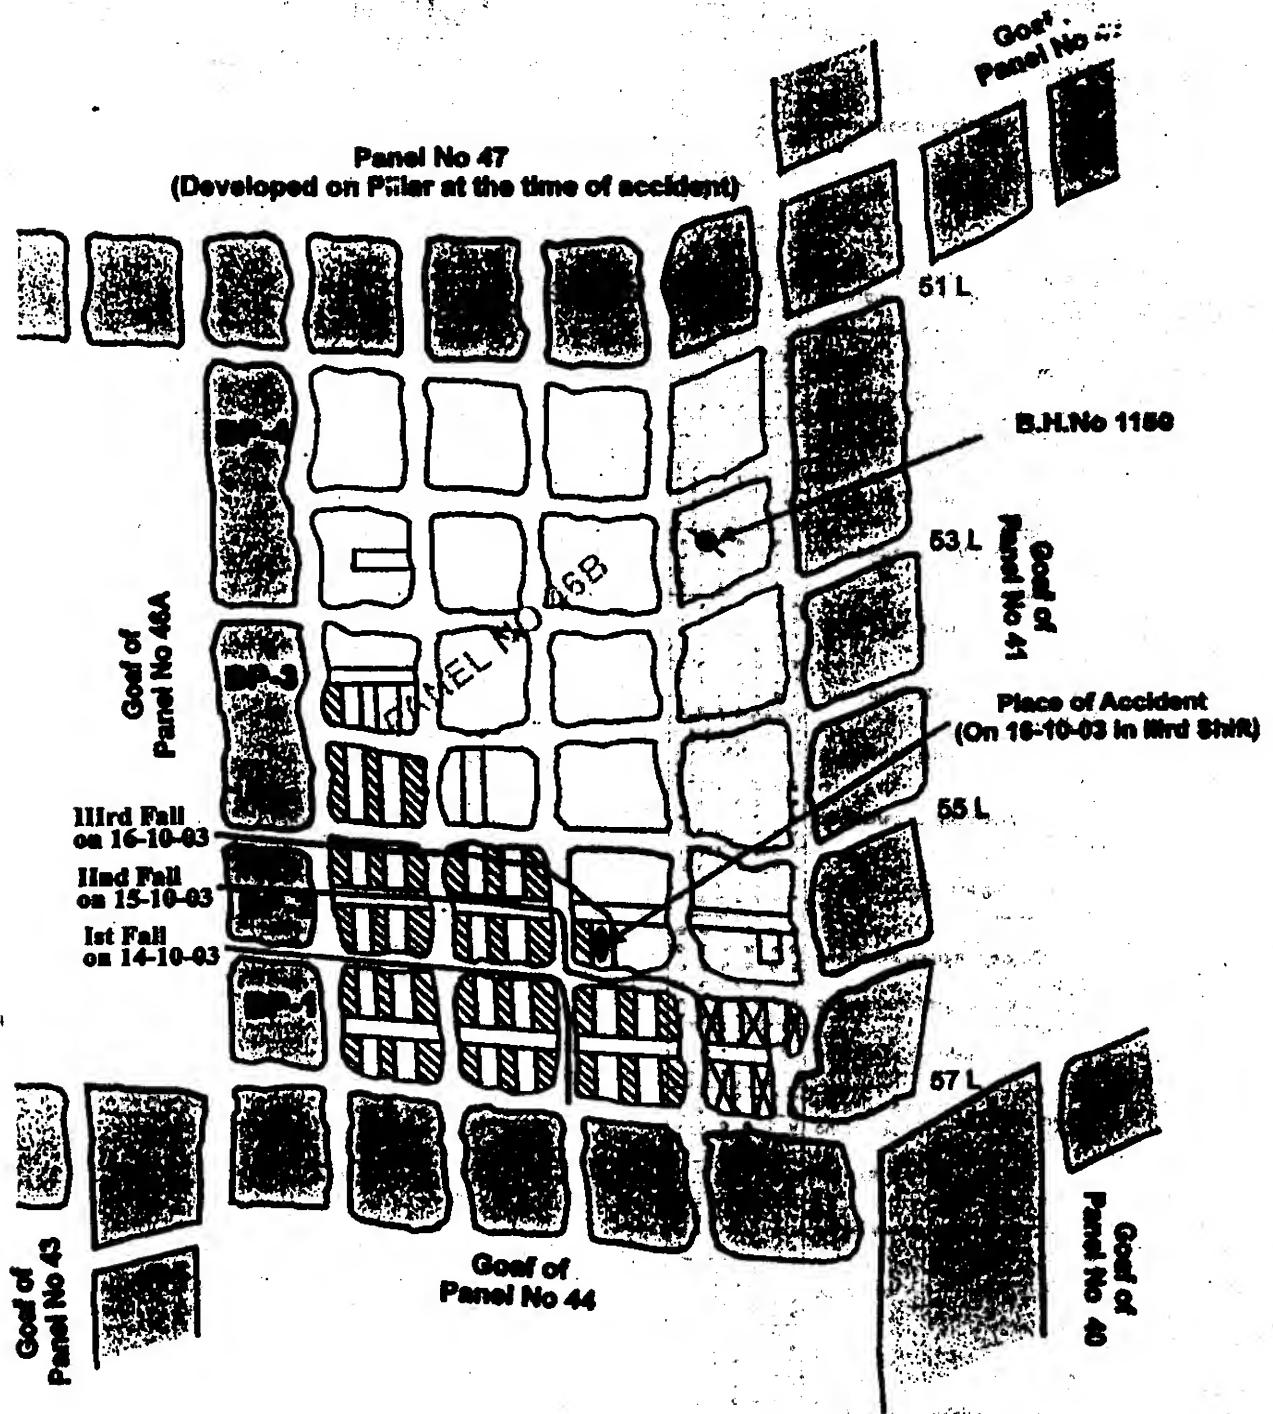
Fig 2: Part plan of the panel no 46B showing line of different falls. Bore Hole position from where rock sample were tested in CMRI laboratory for modelling.

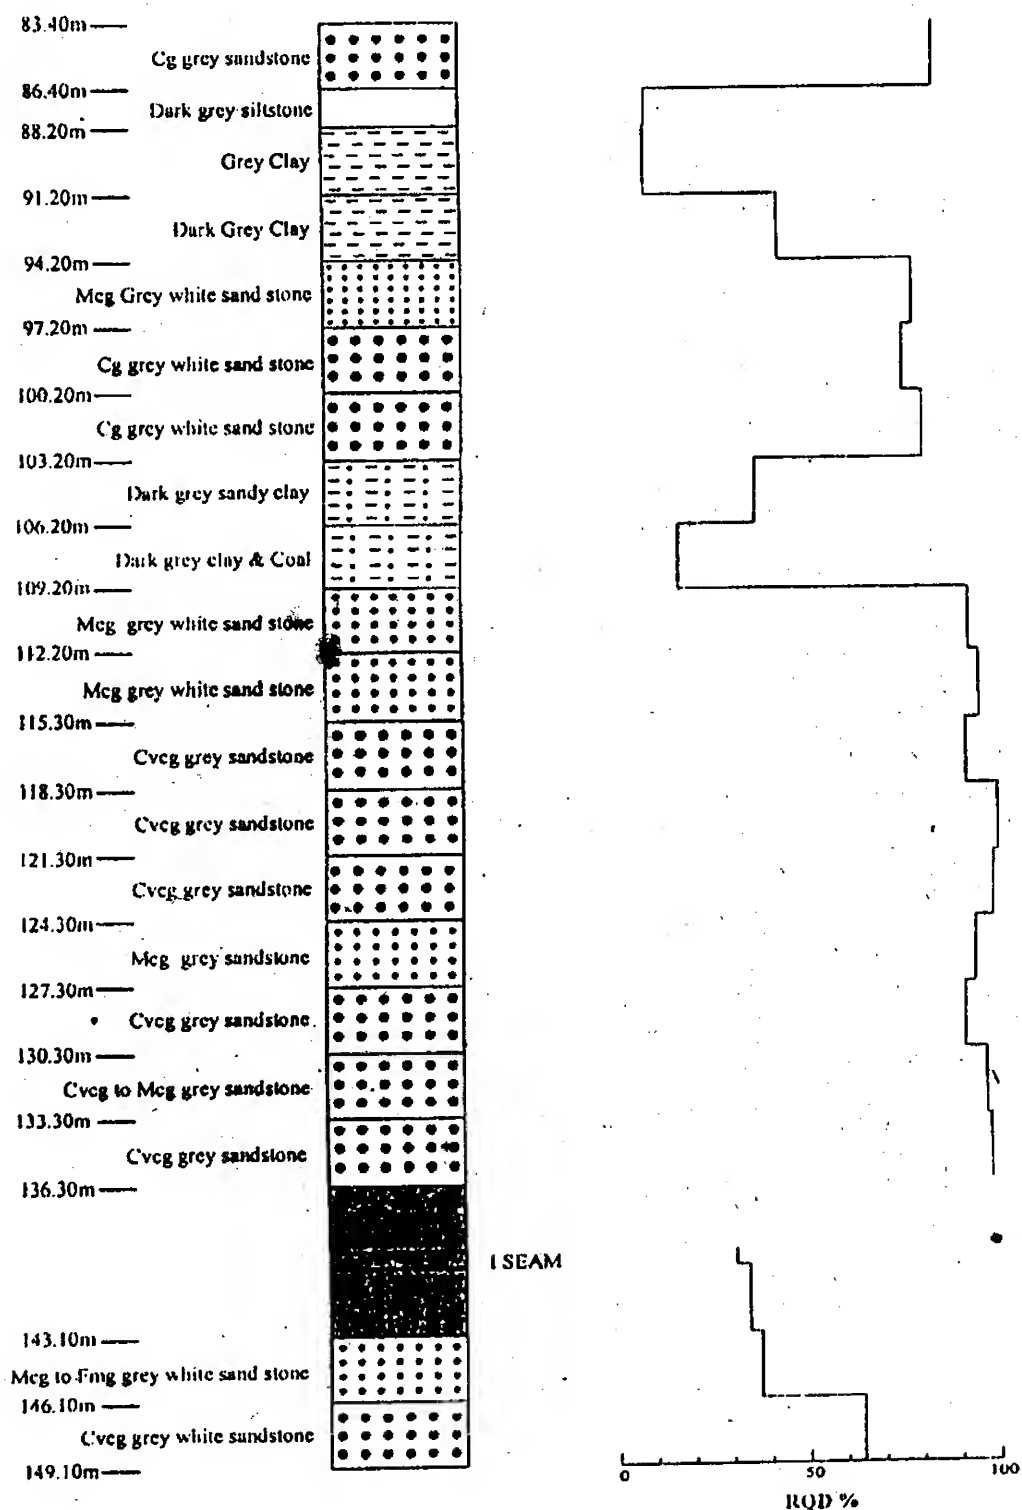
Fig 3: Section along Bore Hole No 1150, located at panel no 46B, whose rock samples were tested for modelling purpose.

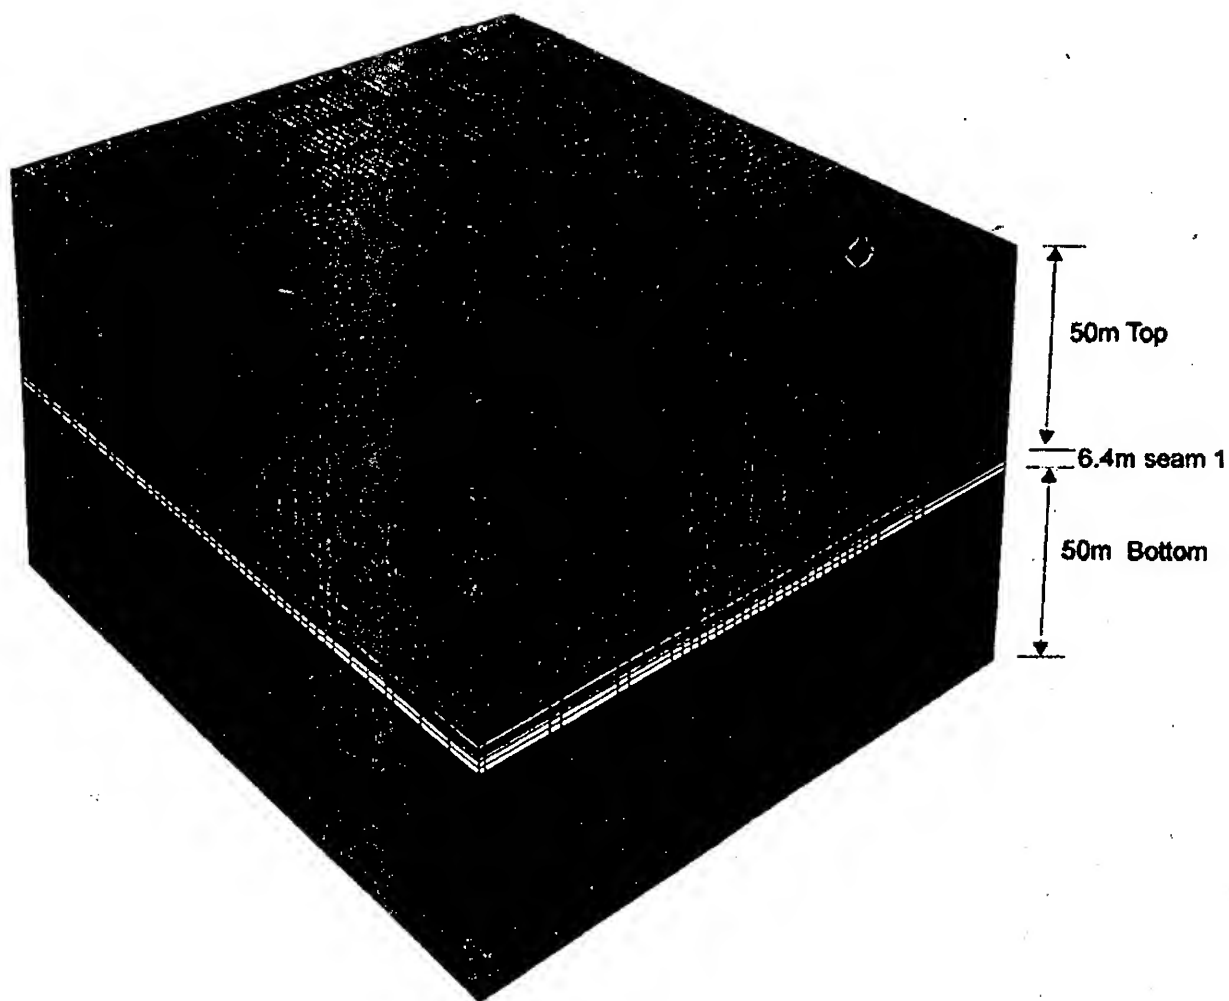
Fig.5: 3-D model showing grid pattern above and below the seam 1 at GDK 8A Incline

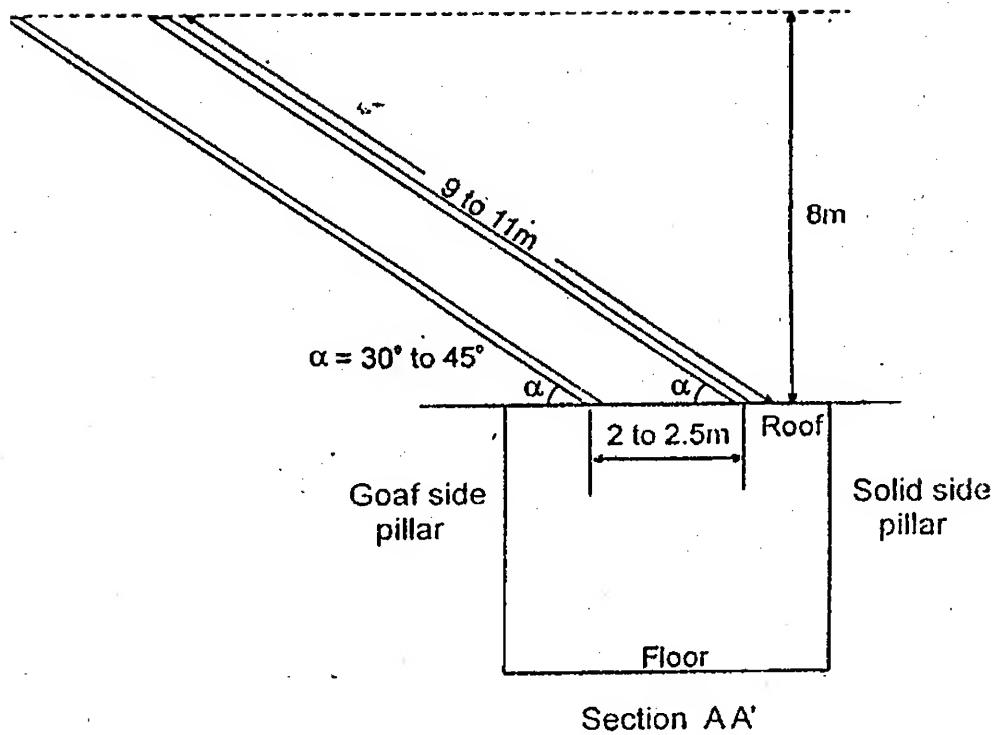
Fig. 9: Goaf edge blasting pattern for induced caving

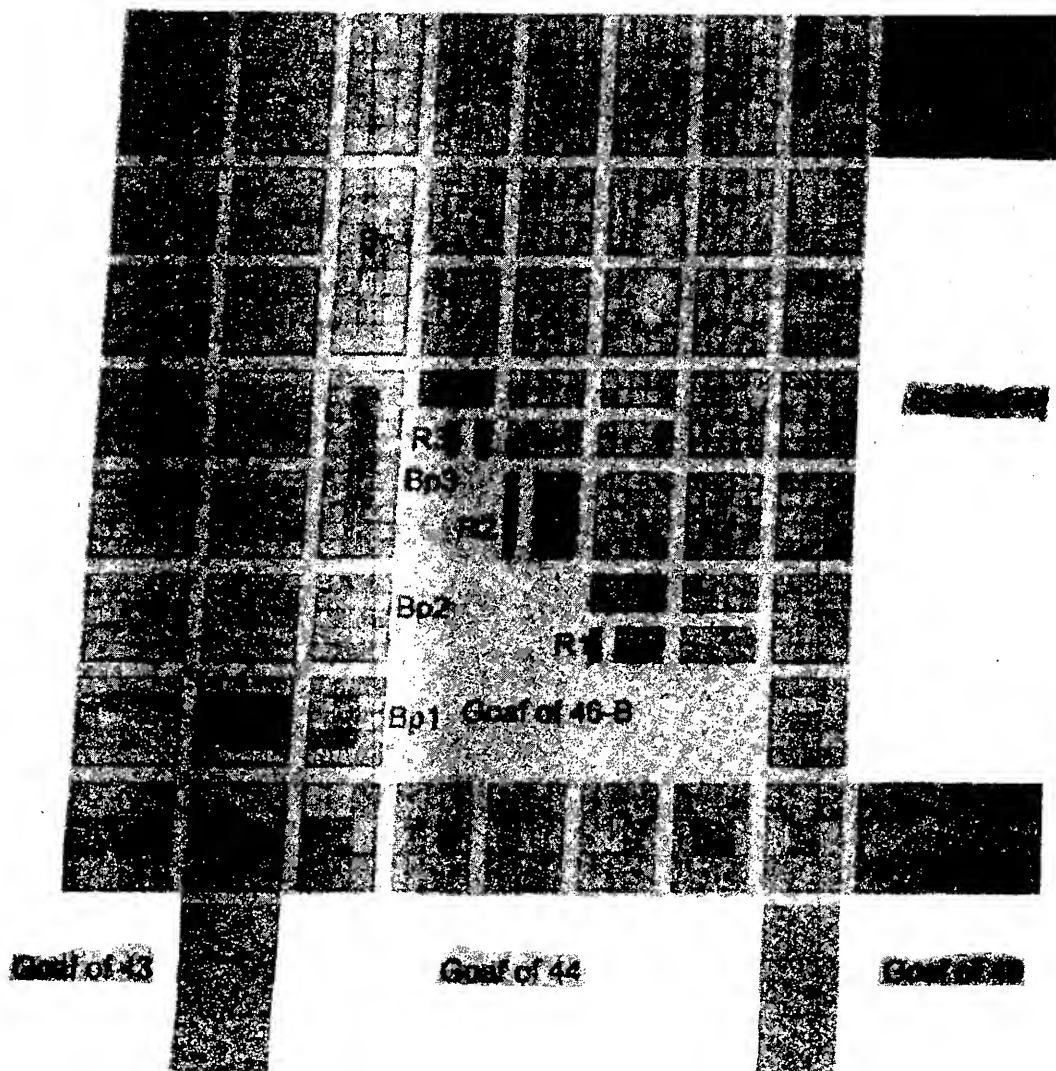
Fig7: Block contours of safety factor over different pillars of panel no 46 B with 46A panel only developed

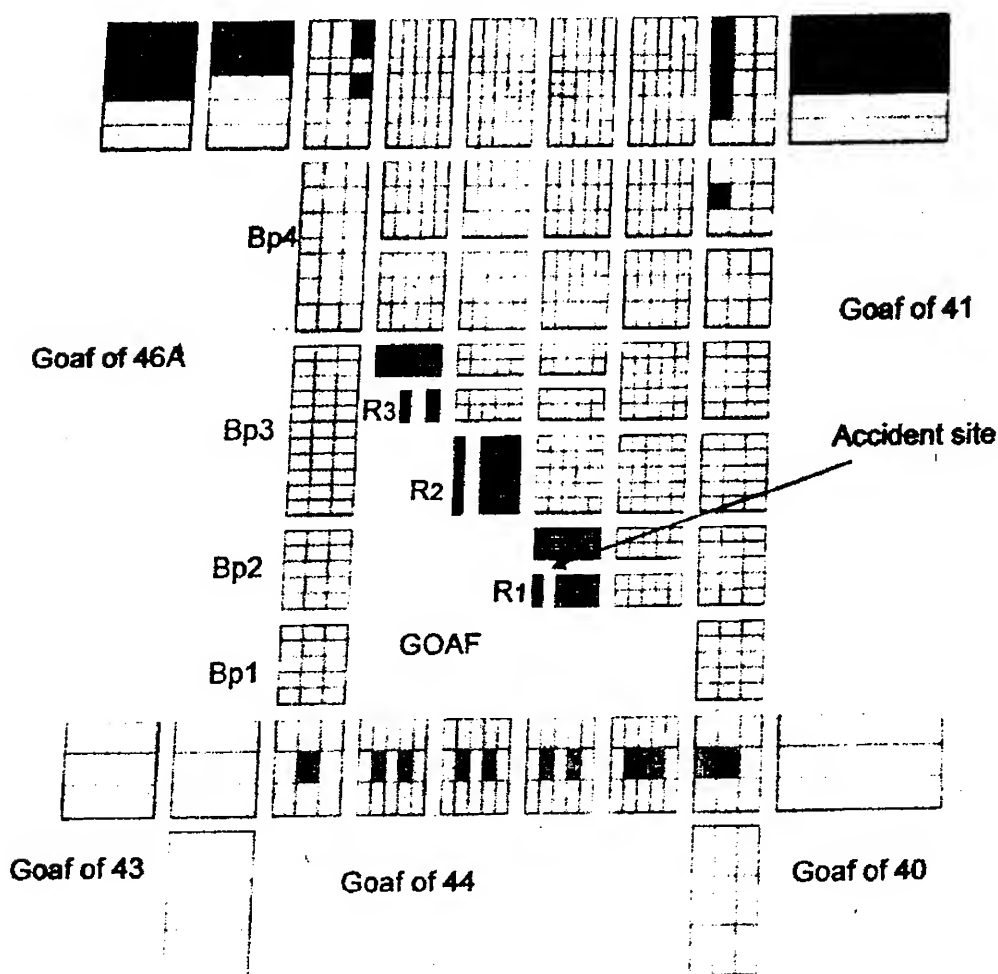
Fig. 6: Block contours of safety factor over the pillars with 3 sides of panel 46-B already extracted

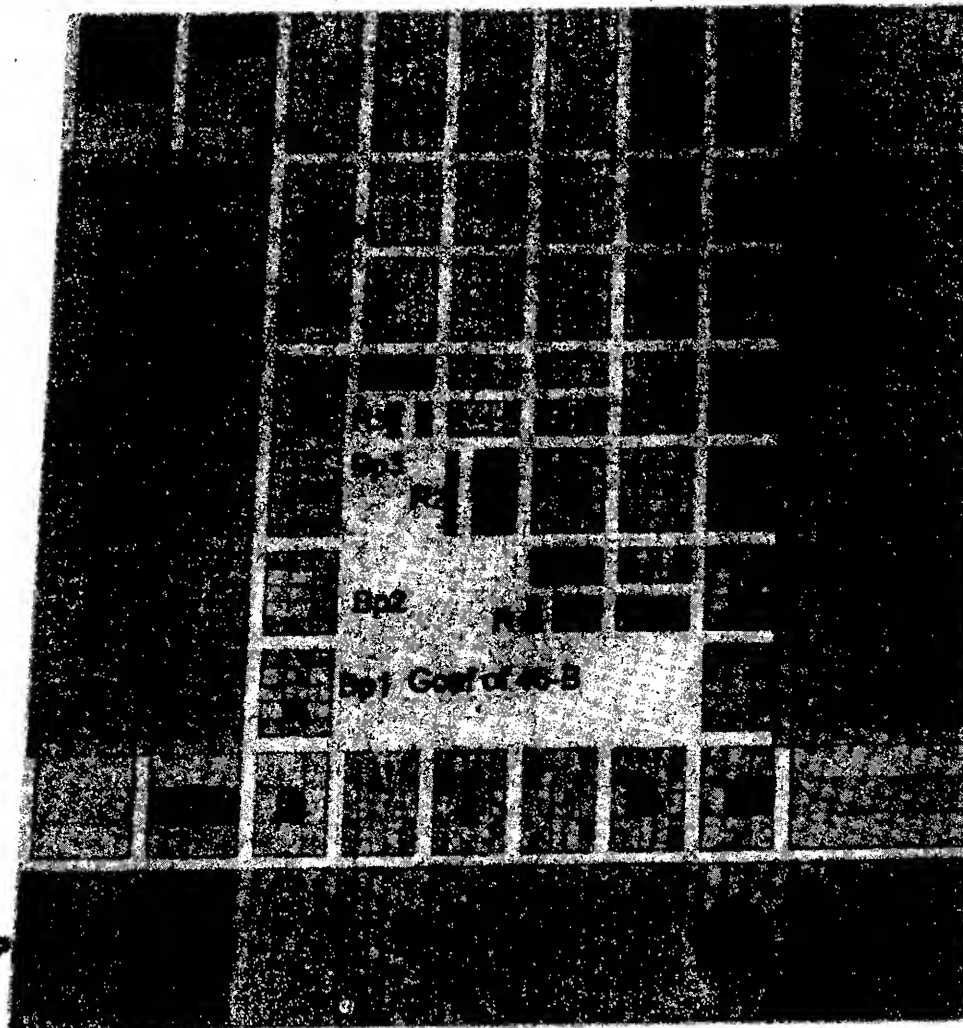
Fig.8: Block contours of safety factor over pillars with 3 sides of the panel no 46-B was extracted but goaf was completely settled
